Periodic Inspection of Jetties at Manasquan Inlet, New Jersey

Armor Unit Monitoring for Period 1994-1998

*by Robert R. Bottin, Jr., WES
William F. Rothert, Philadelphia District*

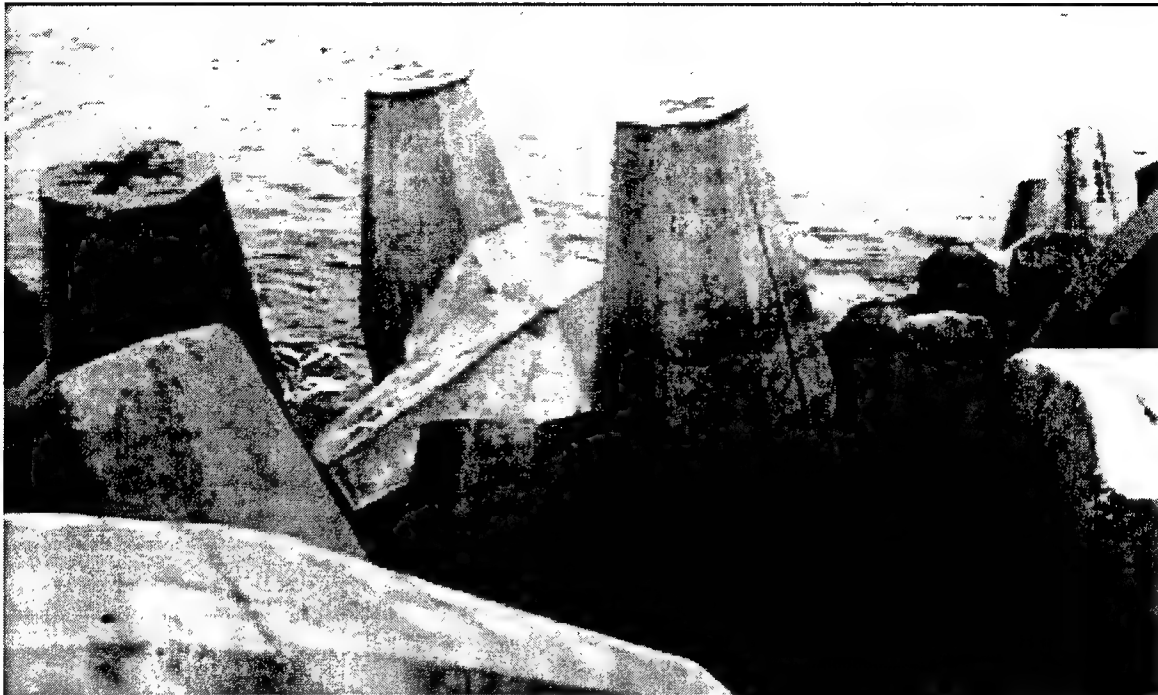
Twenty-nine CORE-LOCs were placed on the north jetty and 16 on the south jetty interlocking with the existing dolosse. In addition, nine dolosse were repositioned to improve the interlocking effect of the dolosse armoring, and several broken units were removed. Other dolosse were repositioned slightly to provide space for the new CORE-LOCs into the overall protection plan. A view of a CORE-LOC armor unit on the south jetty head is shown in Figure 11.

Figure 11. View of 17,235-kg (19-ton) CORE-LOC armor unit on head of south jetty after 1997 rehabilitation

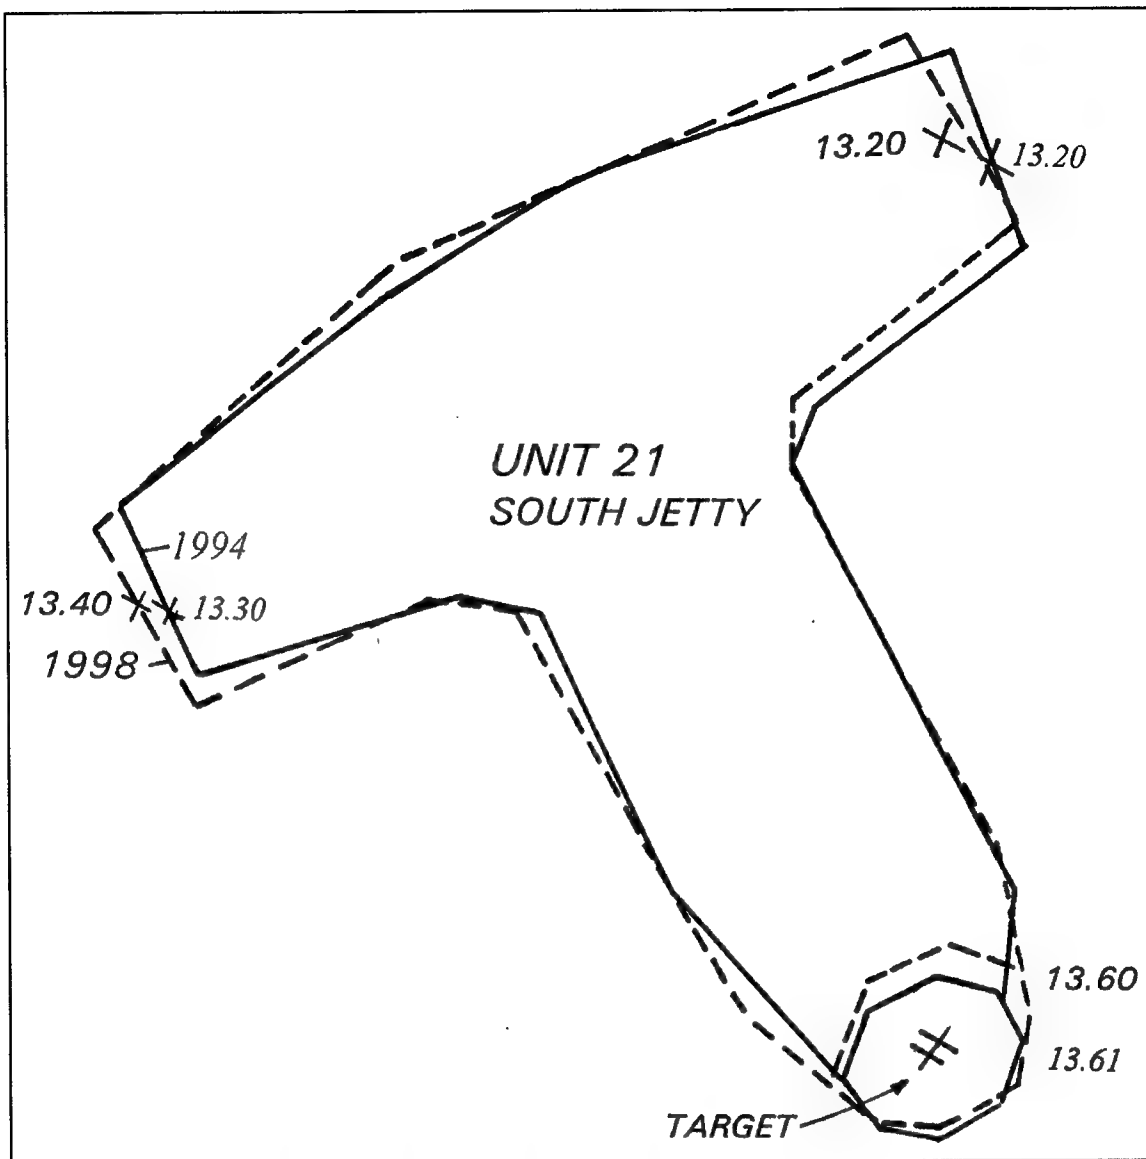
Comparisons of armor unit movement data to this point have included only target data and not movement of the entire armor unit. Therefore, to assess the motions of the entire armor unit, outlines of each targeted dolos were extracted from the stereo models and compared for the 1994 and 1998 surveys. These comparisons depicted horizontal positions, and actual distances moved were scaled off the photogrammetric maps that were prepared. To determine vertical movements of the targeted armor units, additional elevations were obtained from the stereo models at one or two additional points on the dolosse (points other than the established targets). An example of the position of a targeted armor unit and additional elevations for the two surveys is shown in Figure 28.

Figure 28. Example of horizontal position of a target dolosse armor unit and additional elevations obtained for 1994 and 1998 photogrammetric surveys

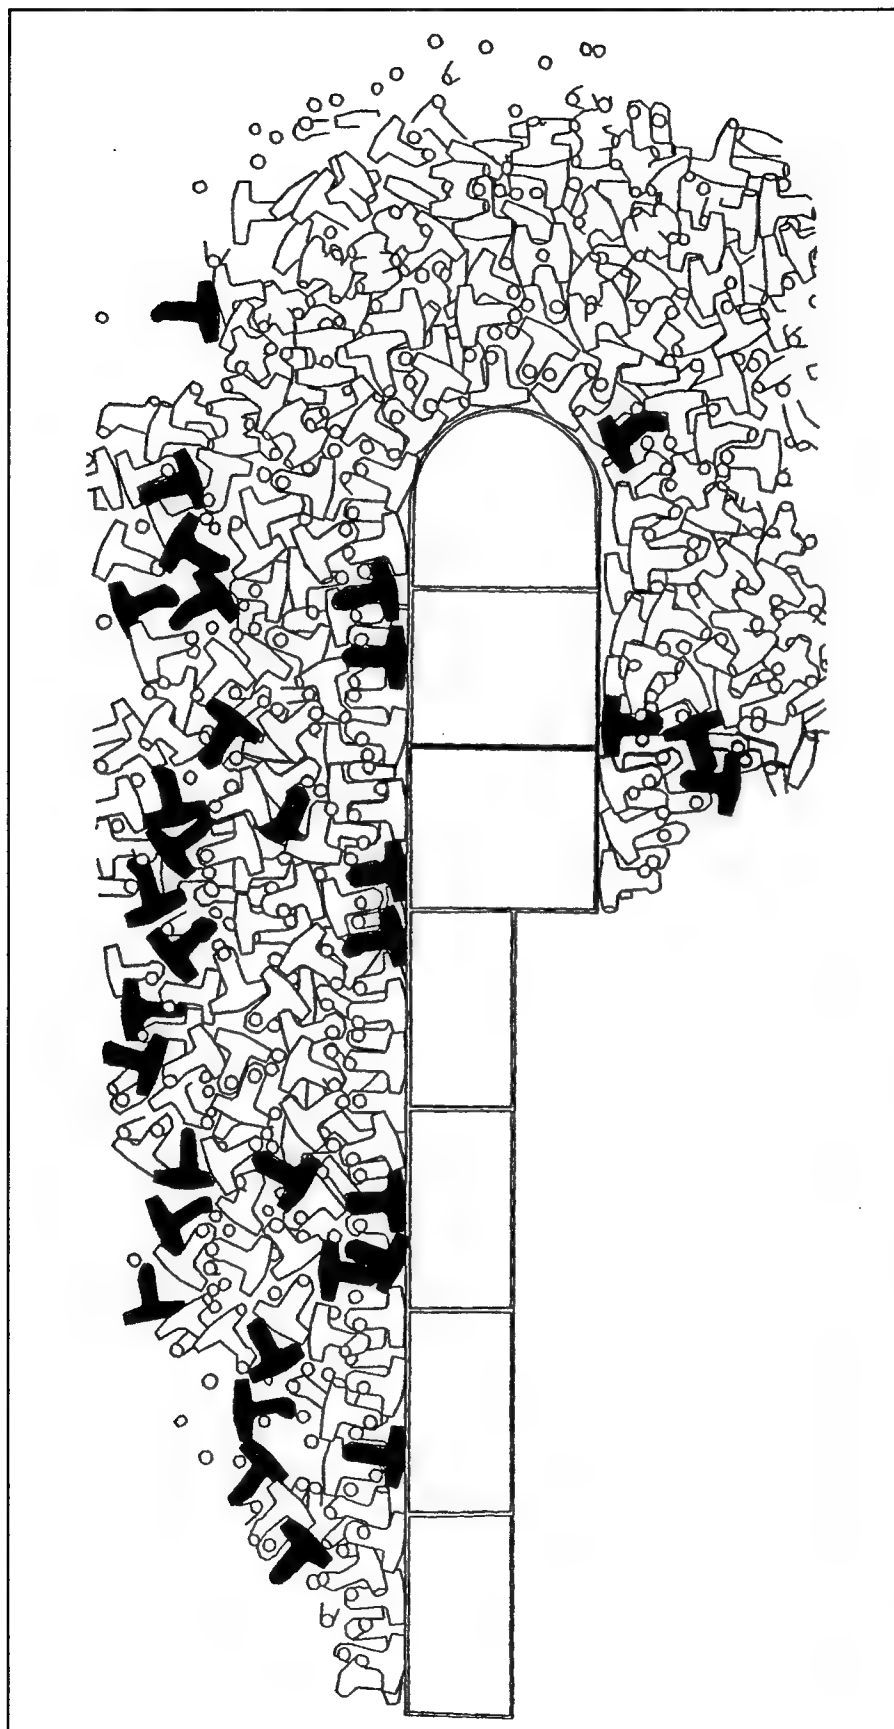
In addition to the targeted armor units, additional (nontargeted) dolosse were selected on the north and south jetties for comparison of movement data between the 1994 and 1998 surveys. The locations of these additional armor units are shown in Figures 29 and 30. Thirty-three dolosse on the north and 29 on the south jetty were selected. Outlines of these additional dolosse, as well as elevations at two or three points on each unit, were obtained from the stereo models for the two surveys and compared on photogrammetric maps to determine horizontal and vertical motions, similar to the procedures used on the targeted units.

Evaluation of the horizontal motions of the additional dolosse indicated that movement was relatively uniform for over half of the armor units, in that the entire unit tended to move in the same direction (nonrotational movement). Forty-five percent of the dolosse on the north jetty and 32 percent of those on the south jetty slightly rotated in either a clockwise or counterclockwise direction. Considering the rotated armor units, there was a dominance of clockwise rotation on the north jetty, and counterclockwise rotation was dominate on the south jetty. In general, of the additional (nontargeted) armor units analyzed that

rotated on the jetties, the majority consisted of those oriented with the vertical fluke farther downslope and the horizontal fluke closer to the jetty center line. Between 1994 and 1998, maximum horizontal displacements for any point on the additional selected armor units were 0.122 m (0.4 ft) on both the north and south jetties. The averages of the maximum horizontal movements of the additional selected dolosse, between 1994 and 1998, were 0.043 m (0.14 ft) and 0.064 m (0.21 ft) for the north and south jetties, respectively. Sixty-six percent of the units on the north jetty and 55 percent of those on the south jetty had maximum horizontal movements of 0.061 m (0.21 ft) or less at any point on the additional selected (nontargeted) dolosse. In general, based on the photogrammetric

Figure 29. Nontargeted dolosse armor units selected for analysis on north jetty

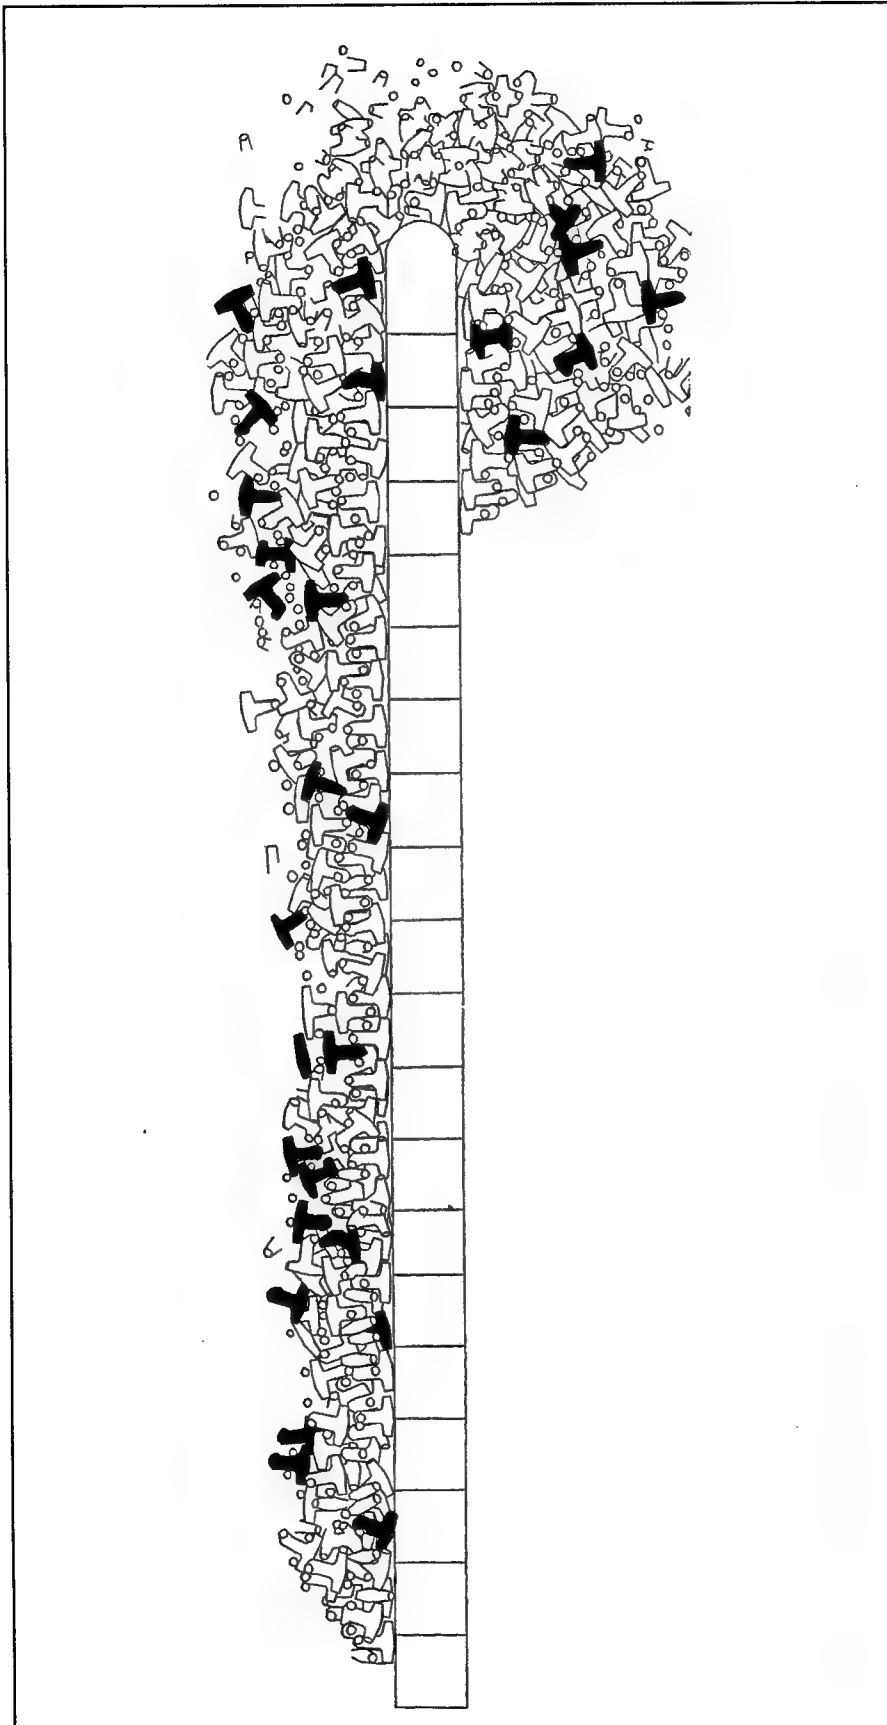
Figure 30. Nontargeted dolosse armor units selected for analysis on south jetty
